4291104

20-11-06 PROBLEM - FINE TRAVERSE NOT WORKING.

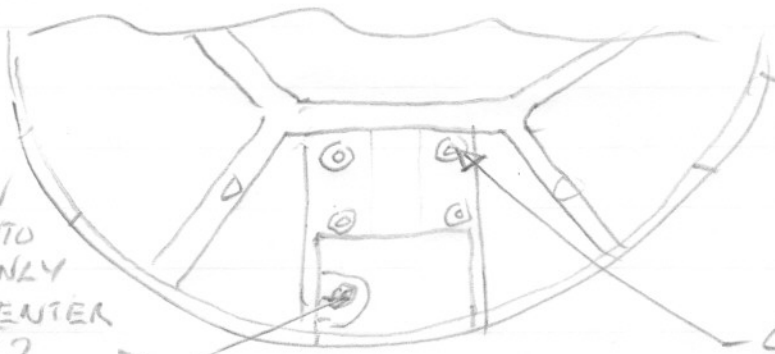
(A) REMOVED 5 - 4MM PAN HD SCREWS FROM UNDERSIDE OF BASE TO RELEASE THE VERTICAL STAND.

NOTE THIS SCREW IS TAPPED INTO THE BASE ONLY & DOES NOT ENTER THE V/STD. ?
EARTHING SCREW?

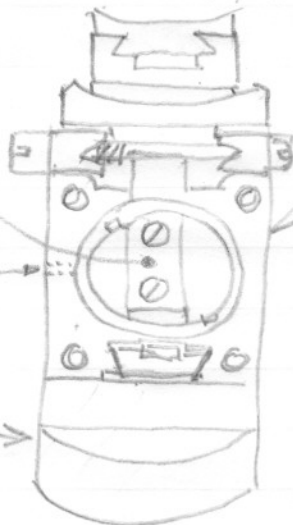
(B) THE UNDERSIDE OF THE V/STAND: -

THIS SUB-ASSY. DOES NOT SLIDE OFF OF THE V/STD. AT THIS STAGE, AN END STOP NOT OBVIOUS PREVENTS THIS.

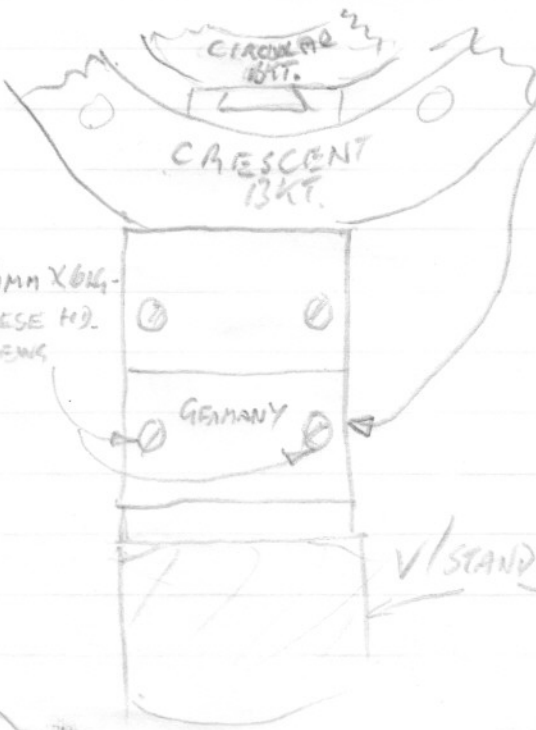
(C) THE OPPOSITE END OF THE ABOVE S/ASSY: -

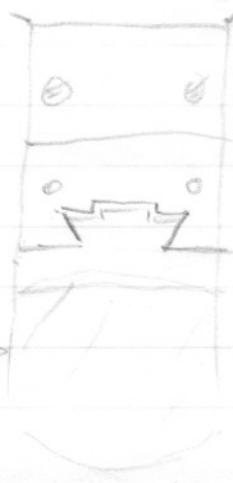
THIS PLATE WAS REMOVED & PROVIDED TO ME THE END STOP, THUS ALLOWING THE S/A TO BE REMOVED FROM THE V/STAND. :-

RACK ON V/STAND NOW EXPOSED.

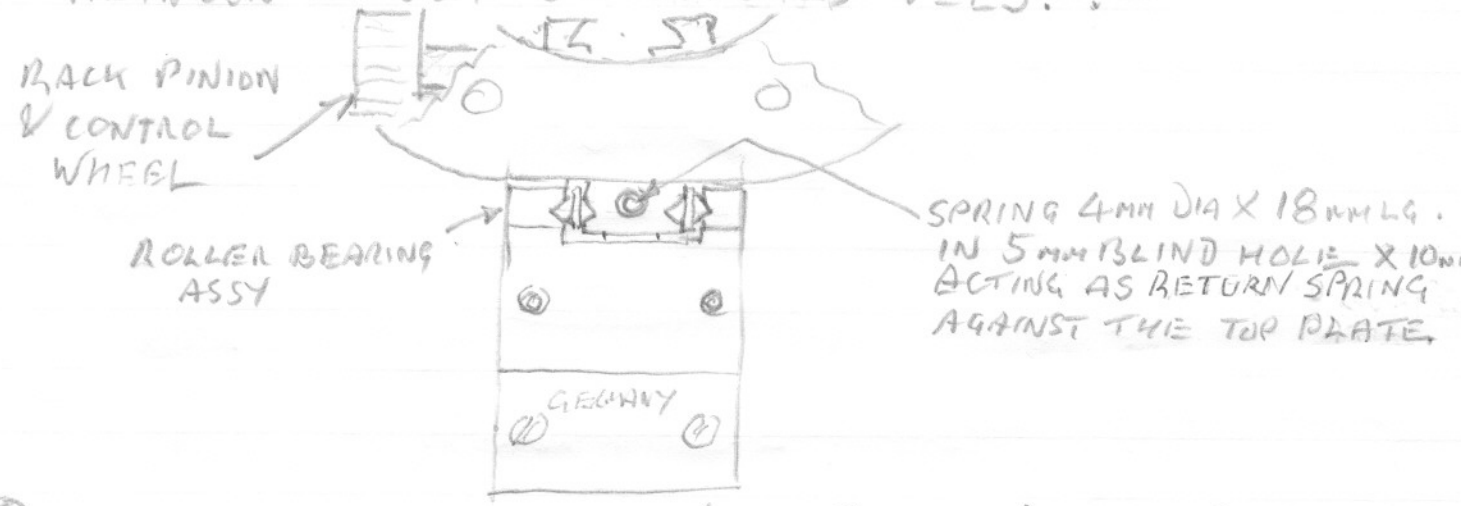
(D) THE STOP PLATE WAS REPLACED & THE FORWARD PLATE REMOVED EXPOSING THE END OF A COMPRESSION SPRING & A TWIN SET OF ROLLER BEARINGS SET BETWEEN A SET OF OPPOSED VEES. :-

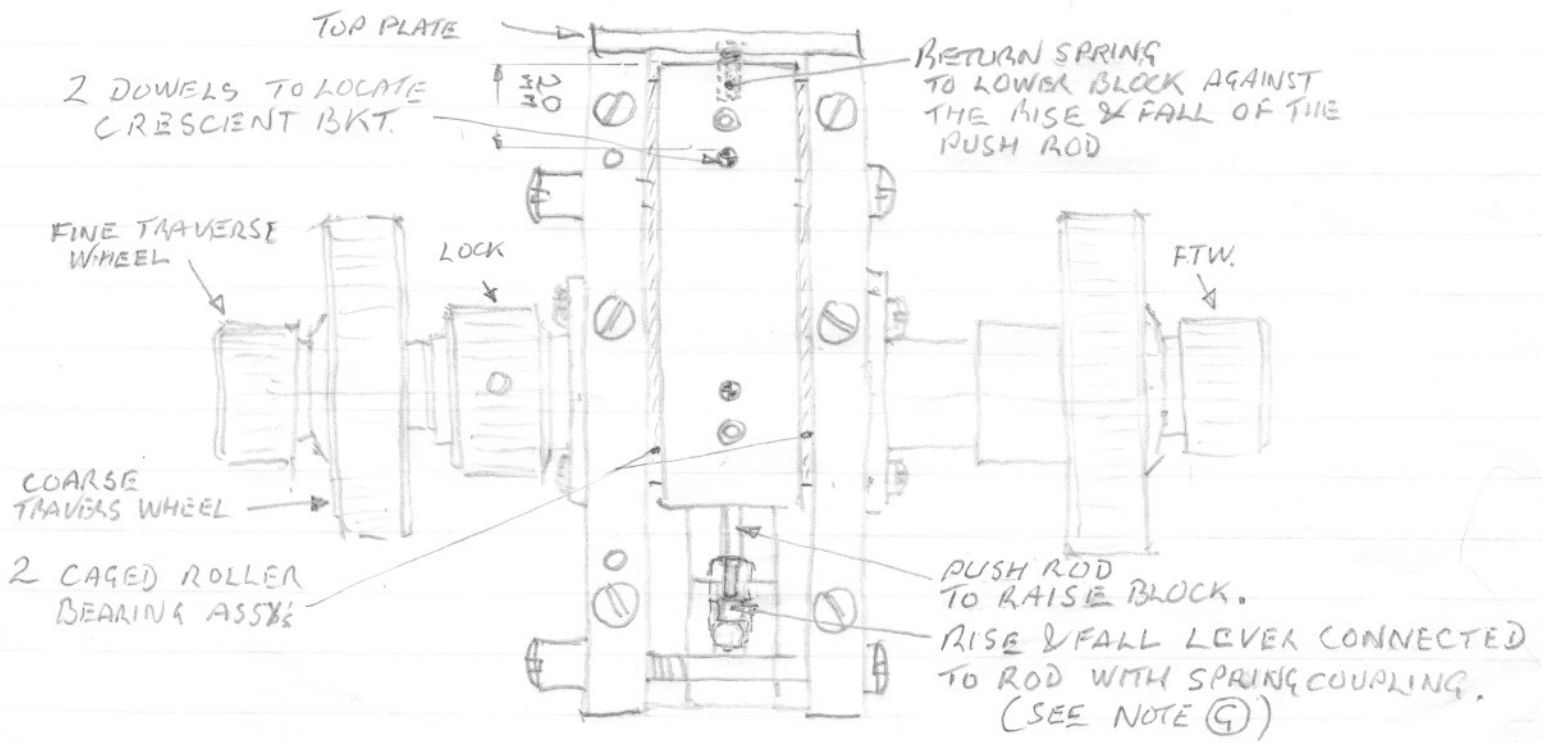
(F) 2-4MM SCREWS WERE THEN REMOVED ALLOWING THE CRESCENT BKT. TO BE WITHDRAWN FROM ITS 2-3MM DOWELS. THIS NOW EXPOSES THE CENTER BLOCK OF THE ROLLER BEARING ASSY. :-

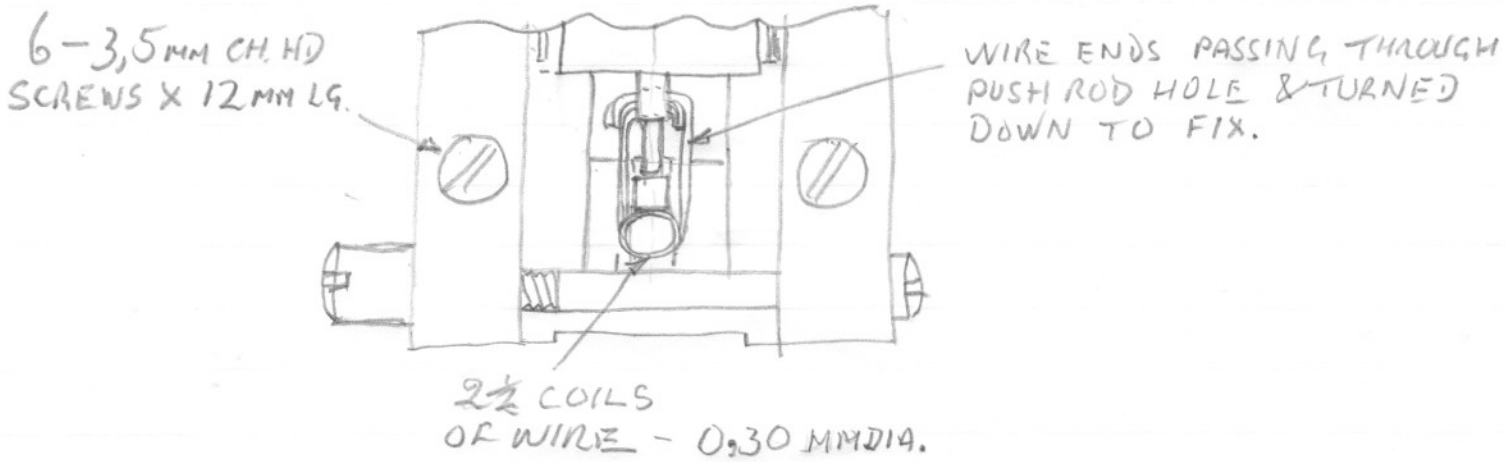
(G) DETAIL OF RISE & FALL LEVEL AGAINST THE PUSH ROD, AND SPRING WIRE CONNECTING ASSEMBLY:-

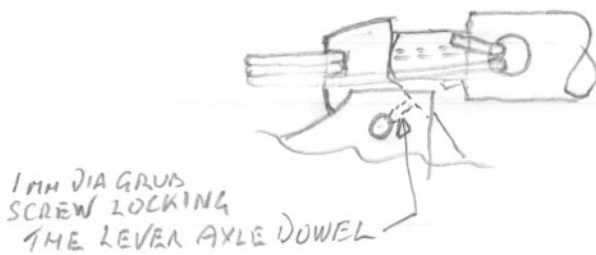
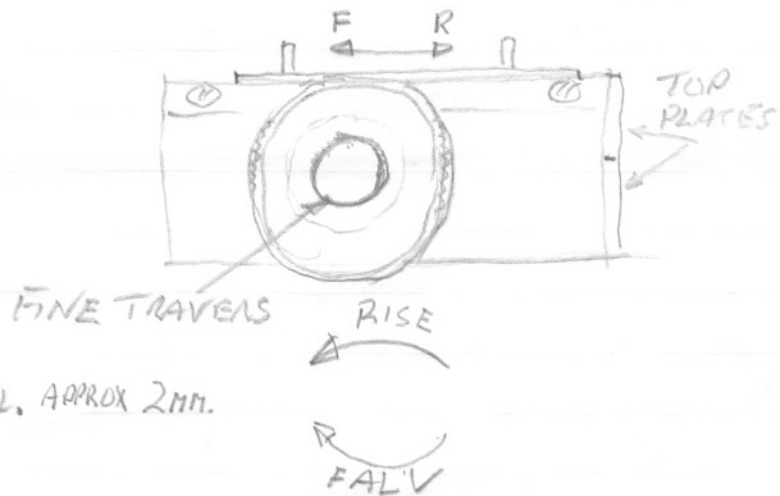
SIDE VIEW OF SPRING COUPLING OF PUSH ROD TO RISE & FALL LEVER:-

FINE TRAVELS RISE & FALL, APPROX 2MM.

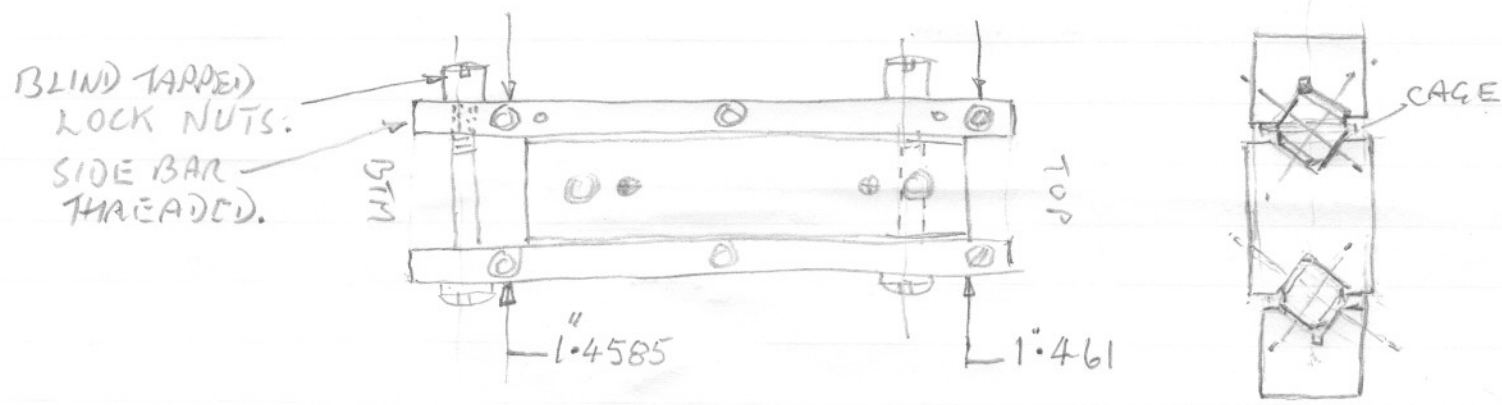
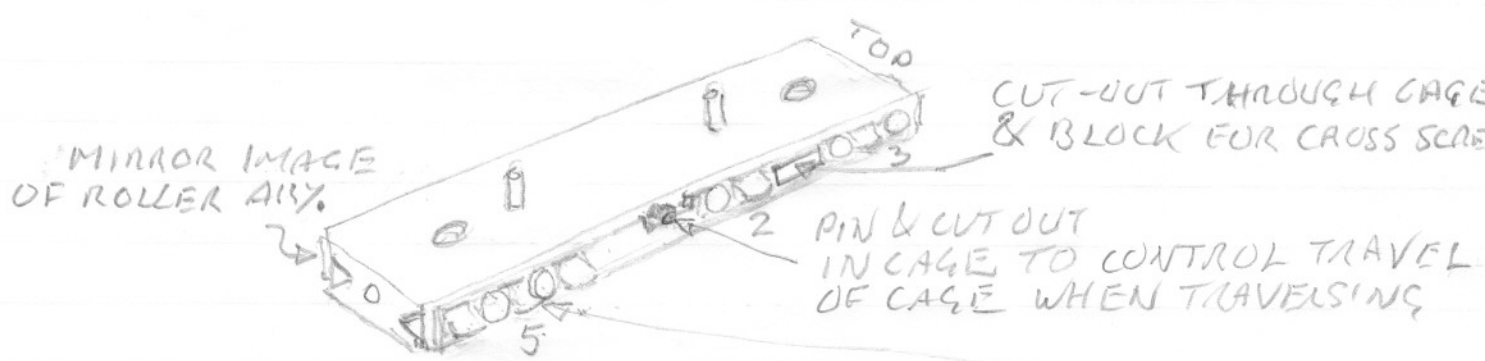
(J) THE ROLLER ASSY TRAVERSE WAS NOT SMOOTH & WAS DISMANTLED! —

WIDTH DIMENSIONS TAKEN TO ASSIST RE-ASSEMBLY.

10-ROLLERS ASSEMBLED ON ALTERNATIVE AXIS.

THE CONGEALED & HARDENED GREASE WAS DISSOLVED OFF IN ISOPROPYL ALCOHOL.

ROLLERS ARE 4.00MM DIA X 3.98MM LG. 20 OFF.

THE ROLLERS TOGETHER WITH THE CENTRE SECTION & SIDE MEMBERS WAS RE-ASSEMBLED. WHITE PETROLEUM JELLY B.P. WAS USED TO LUBRICATE.

ON RE-ASSEMBLY THE AXIS OF THE ROLLERS WAS TURNED THROUGH 180° BRINGING THE CONTACT TO THE VEE SURFACE ON A NEW & UNUSED AREA. THIS HAS THE EFFECT OF ADDING APPROX. 0.001 TO THE WIDTH OF THE ASSY. THROUGH OUT ITS LENGTH.

AS RESULT OF THE CLEANING A SMOOTH TRAVERSE HAS BEEN ACHIEVED.

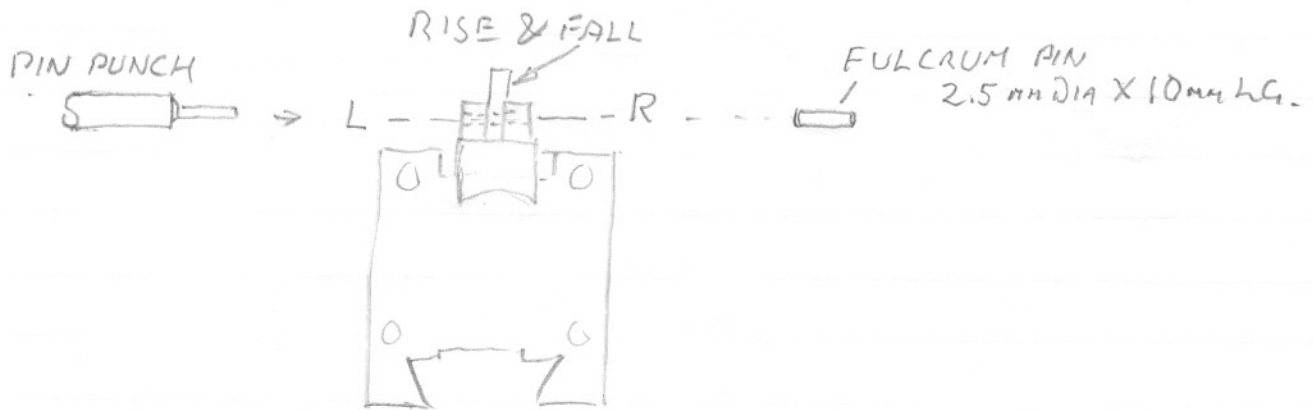
- (K) THE FULCRUM PIN FOR THE RISE & FALL LEVER WAS REMOVED (SOME FORCE WAS NEEDED) & THE LEVER LIFTED OUT.
THE REMOVAL OF THE PIN WAS LEFT TO RIGHT.

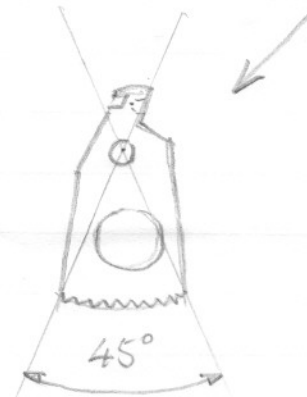
THE RISE & FALL LEVER WAS REMOVED.

THE TEETH (14) ON THE LEVER WERE MUCH WORN & BURRED, BUT NOT STRIPPED AS TO PREVENT SOME ENGAGEMENT WITH THE PINION.

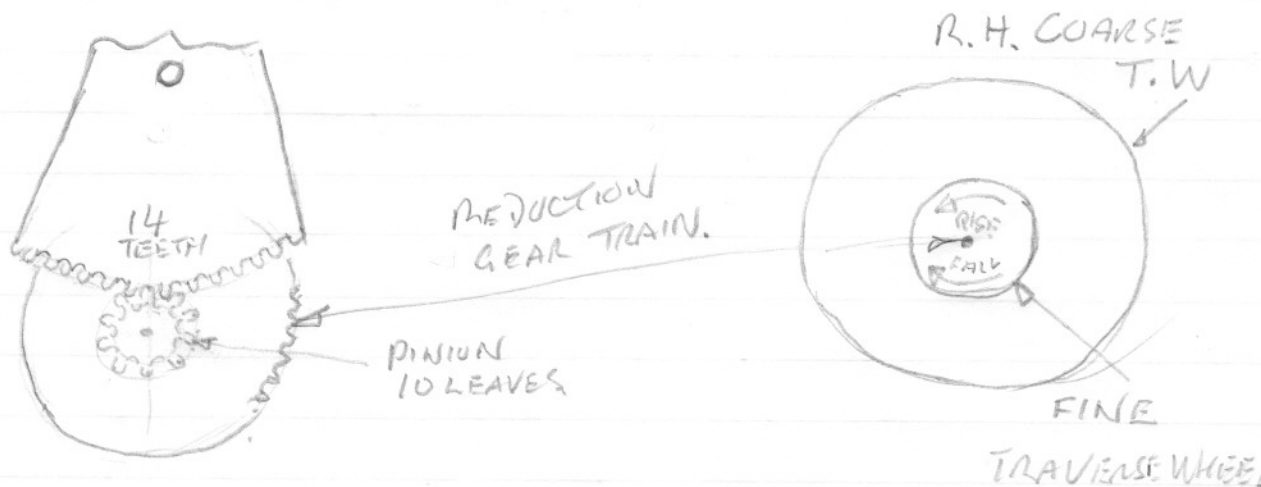
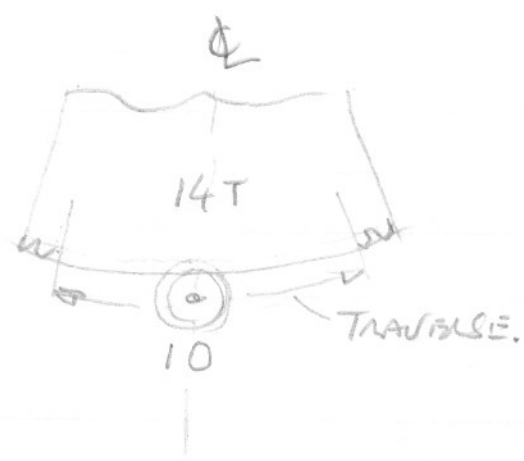
THE FINE TRAVERSE WHEEL REQUIRES 20 REVOLUTIONS BETWEEN STOPS, THE 10 LEAF PINION 1 REVOLUTION i.e. 20 to 1 REDUCTION THROUGH GEAR TRAIN.

IF THE ASSEMBLY CAN BE ARRANGED ON THE CENTRE LINE OF THE PINION & LEVER. THERE WILL BE 2 UNENGAGED TEETH EACH END.

THIS WILL PREVENT RUN-OFF AT THE ENDS WHICH APPEARS TO HAVE BEEN ONE OF THE PROBLEMS. THIS HAD CAUSED DAMAGE TO THE END TEETH WHEN RE-ENGAGING.

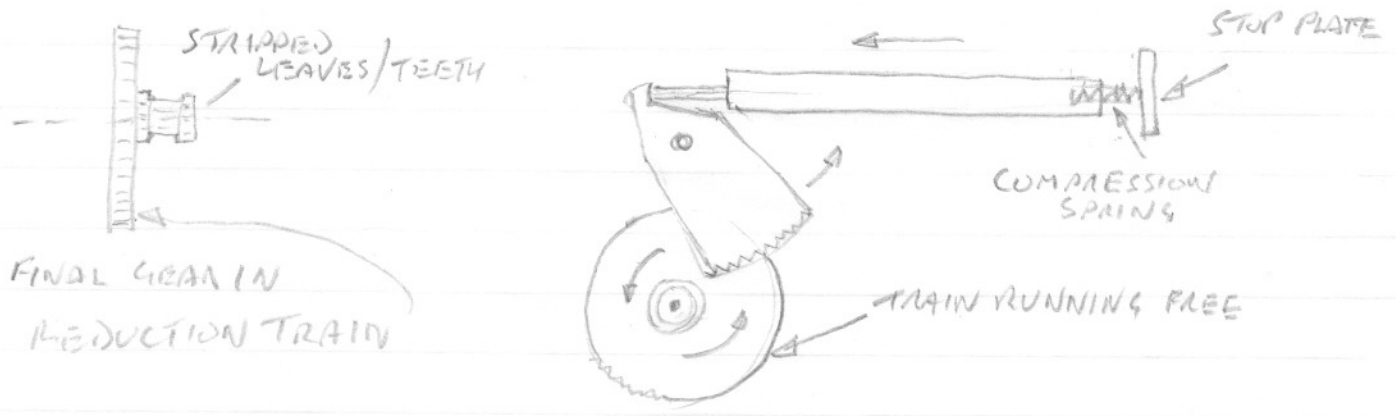
(M) FURTHER EXAMINATION OF THE REDUCTION TRAIN REVEALED THAT THE 10 LEAF/TOOTH PINION ENGAGING WITH THE RISE & FALL LEVER WAS STRIPPED TO THE EXTENT THAT IT ONLY ENGAGED INTERMITTANTLY AND THAT WITH THE RESISTANCE OF THE COMPRESSION SPRING DURING THE RISE SEQUENCE IT CAUSED THE LEVER TEETH TO PASS THROUGH & DISENGAGE. THE RISING BKT. ATTACHED TO THE ROLLER SLIDE ASSY. WOULD THEN DROP TO THE BOTTOM.

(3) THE ANSWER TO THE PROBLEM IS THE REPLACEMENT OF THE GEAR & PINION ASSY. DUE TO THE STRIPPED PINION TEETH & THE REPLACEMENT OF THE RISE & FALL LEVER DUE TO THE DAMAGED RACK OF TEETH THAT ENGAGE WITH THE PINION.

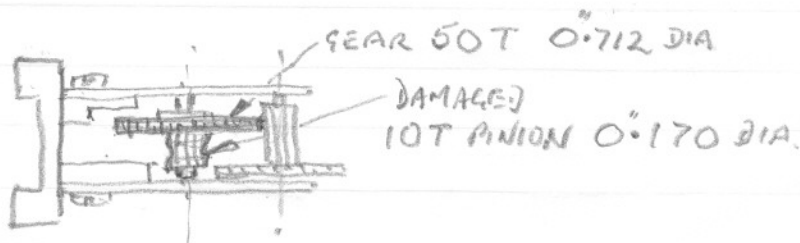
(2) THE LOCKING SCREW TO THE RING NUT (NOTE 'B' SHT 1) WAS REMOVED & THE RING NUT TURNED ANTI CLOCKWISE ALLOWING THE GEAR TRAIN ASSY TO BE REMOVED. A SPECIAL KEY WAS MADE TO FIT THE INTERNAL CUT-OUTS OF THE RING NUT. CONSIDERABLE TORQUE WAS NECESSARY TO REMOVE THE RING NUT RESULTING IN BURNING OF THE CUT OUTS. DRIED OIL HAD POSSIBLY LOCKED THE NUT, ALSO THREA) DAMAGE CAUSED BY THE LOCKING GRUB SCREW.

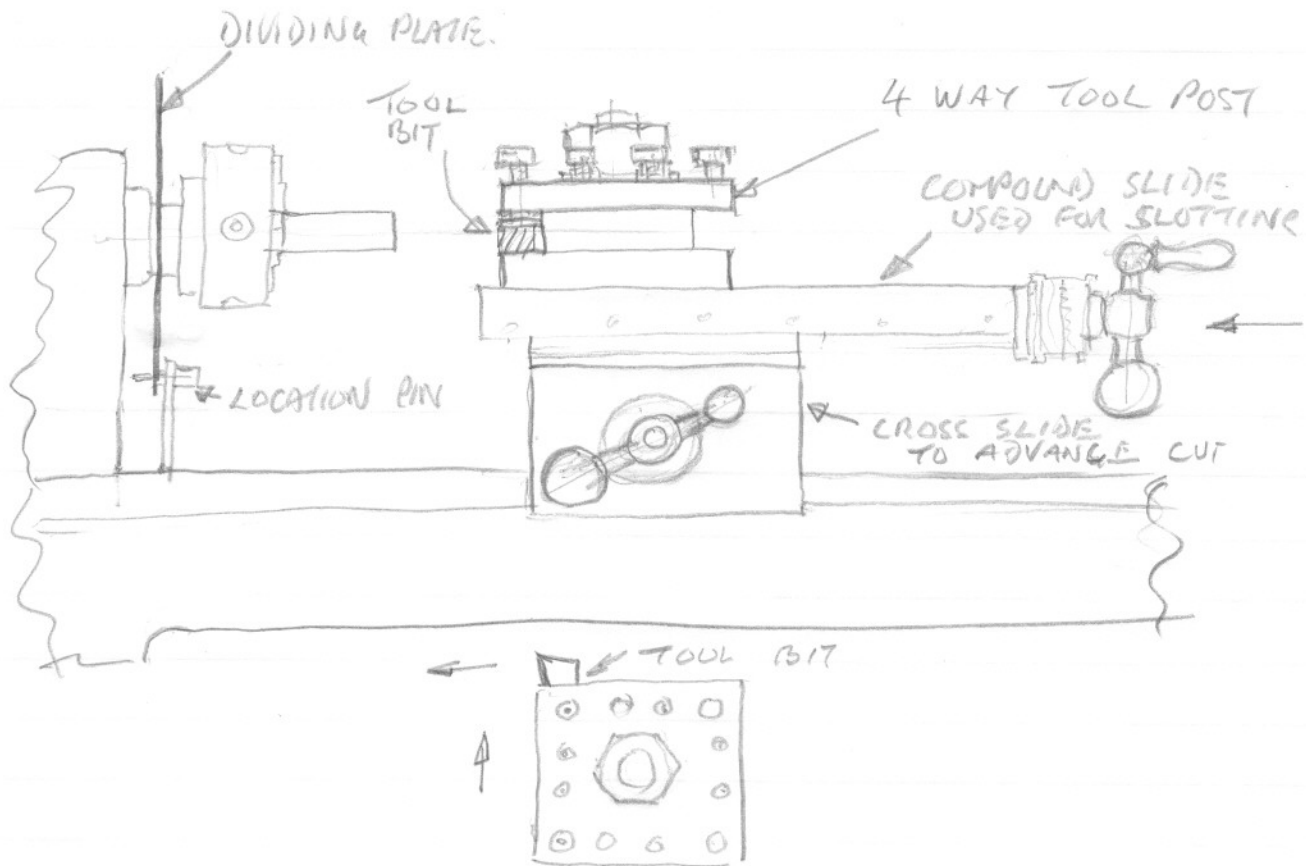
A DIVIDING PLATE FOR 10 TEETH WAS POSITIONED BEHIND THE LATHE CHUCK AND A $\frac{5}{16}$ " DIA STEEL ROD CHUCKED.
